## St Mary's Church, Thornborough, Bucks.

### *Observations on the south wall of the nave following the removal of plaster*

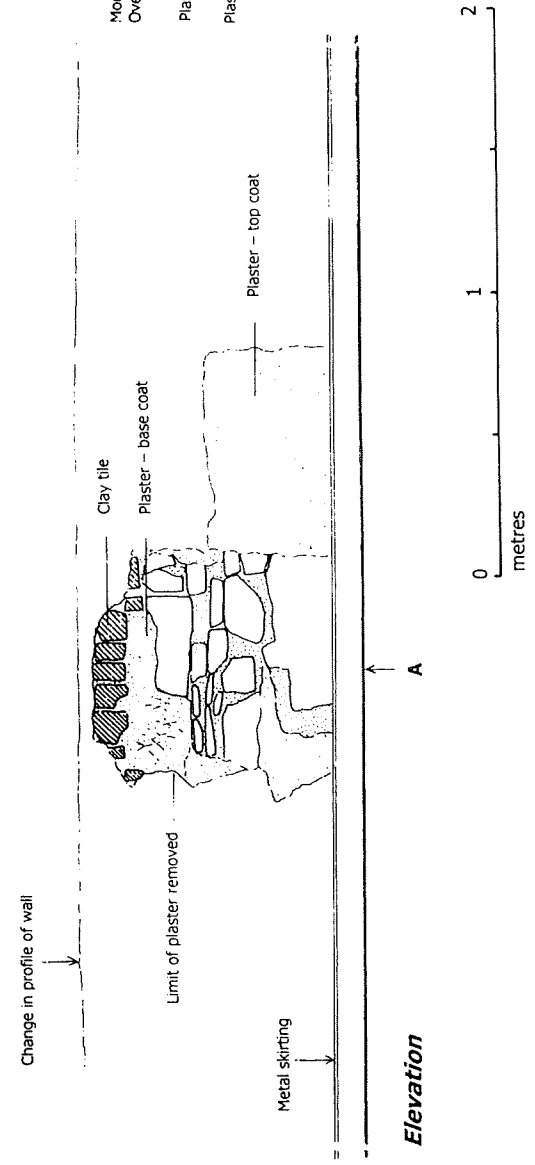
**Section across line A-B**

It is noticeable that the tiles also correspond with a gradual thickening of the wall at this point (as shown on the section drawing) so that the width of the wall increases by up to 60 mms where the tiles have been applied. This increase in the width continues to the base of the wall and also runs along virtually the full length of the south wall of the nave. The change in thickness may correspond with a slight step in the original construction of the wall, which was then partially obscured by running the plaster at a sharp angle to create a steeply shelving shoulder, rather than retain the step. This suggestion could be investigated further if slightly more plaster was removed from the wall above the tiles.

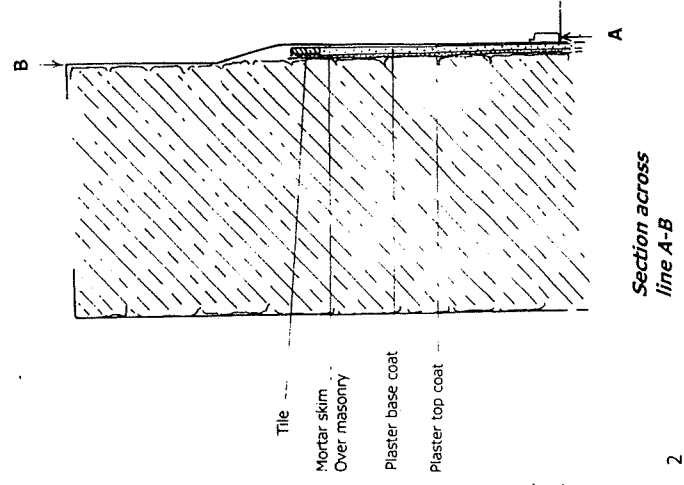
**Elevation**

As a result of removing the plaster the original masonry construction of the wall was exposed. The wall is made up of rubble limestone of irregular construction i.e. without deliberate coursing. Blocks of masonry of varying size have been used, the largest at the base of the exposed section measuring at least 0.5 metres in length and 0.2 metres in depth. Smaller blocks and thin slivers of limestone have also been used as packing between the blocks. The whole construction is bonded with a soft light brown coloured lime mortar containing coarse aggregate.

A row of broken clay tiles was also revealed along the top edge of the damaged area, as shown by the diagonal hatching on the elevation drawing. This was thought at first to be the head of a low arch set into the wall. However, close inspection revealed that the pieces of broken tile were in fact pressed against and applied to a thin skim of lime mortar covering the masonry construction of the wall. The clay tiles appeared to be pieces of re-used medieval floor tile since they were slightly irregular in outline, with a thickness of 23 mms. None of the pieces carried any decoration but there was some trace of a lead glaze on several of the tiles. The largest of these pieces measured 12 x 12 cms, the smallest consisted of small fragments.

From the limited evidence available it is difficult to determine whether or not the row of tiles continues along the full length of the wall below the shoulder. This would only become more apparent if more plaster is removed. However, such an exercise should only be carried out if the plaster is considered to be in such poor condition that it has to be removed. The plaster is lime based, but probably dates from the 1860s. It does not contain hair, which was a normal addition to medieval plaster, used to add strength to the plaster. Further analysis of the plaster is therefore required before more is removed. If more plaster is removed then the wall construction, including any further tiles, should be recorded. Such work should also be carefully monitored to ensure that surviving sections of medieval plaster – perhaps carrying decoration – are not removed. The tiles should be carefully examined to determine whether or not any carry encaustic decoration, in which case they are likely to be medieval.
