**A REPORT ON AN ARCHAEOLOGICAL EXCAVATION
AND MONITORING AT
100-102 WALTON STREET, AYLESBURY,
BUCKINGHAMSHIRE**

**September 2002
ASC:AWS02/3**

In mid-May 2002 an area 8 by 10 metres was excavated on a site at 100-102 Walton Street, Aylesbury, Buckinghamshire. This was followed up with a programme of monitoring and recording on the subsequent landscaping in August and September of the same year. Though adjacent to the Saxon settlement of Walton the excavation was not deep enough to encounter significant archaeological deposits. A layer of compacted stone ; presumably a farmyard surface, was encountered below made up ground and topsoil. Medieval sherds were recovered from just below the topsoil at the northern end of the site during the monitoring phase

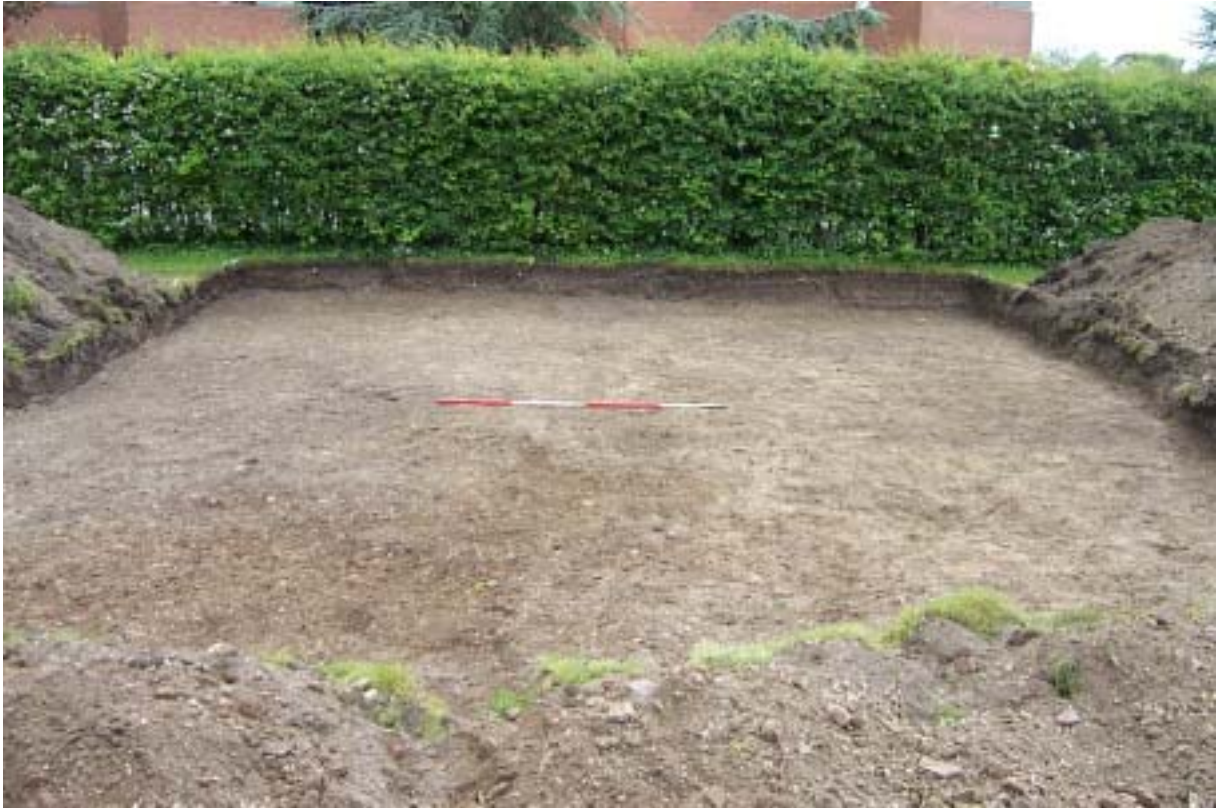
Plate 2: Overall shot of the site

- 5.1 It was immediately clear, subsequent to excavation to the required depth (430mm) that the ground had been deliberately made up, with topsoil placed on top (Plate 2).
- 5.2 The two test pits both revealed a compacted stone surface.
- 5.3 Context Summary:

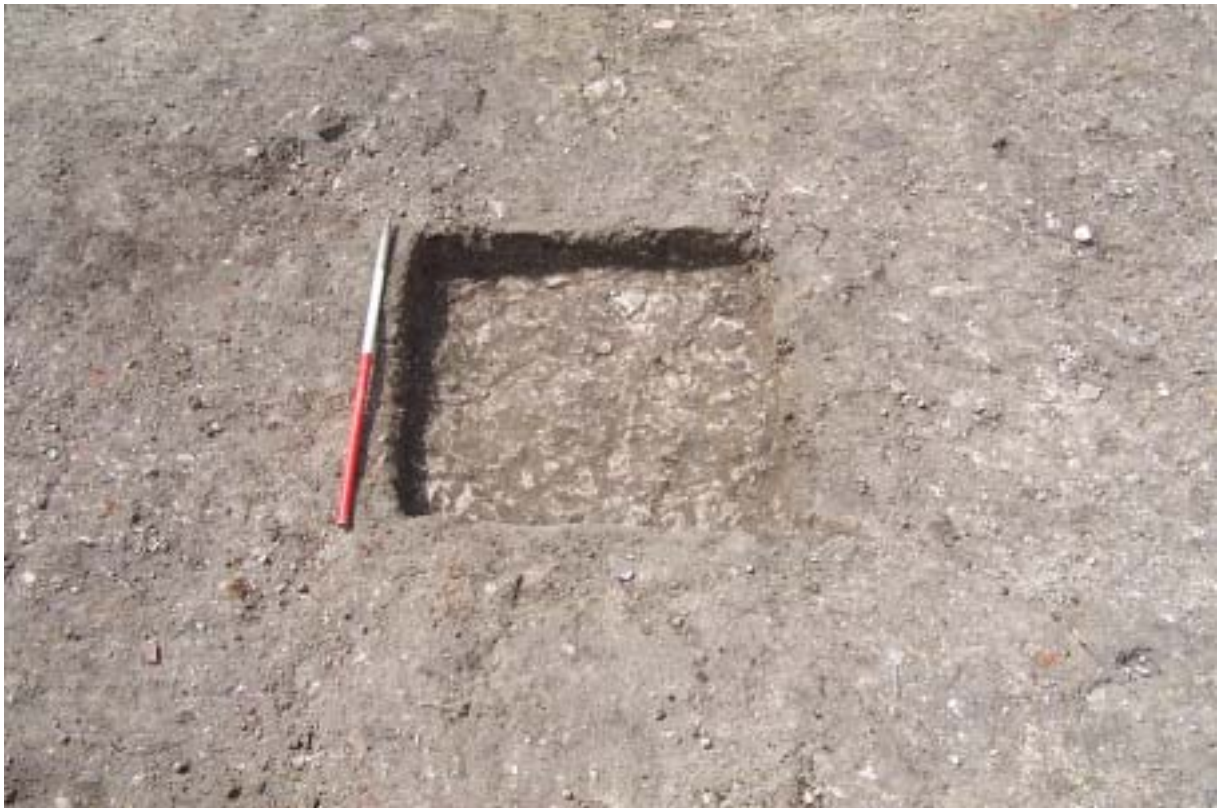
Plate 3: Test pit 1

Context	Description	Depth
1001	Friable, dark brown humic clay: Topsoil	0.0m
1002	Friable, mixed brown and yellowish grey gravelly clay: Made up layer	0.35m
1003	Grey limestone fragments: Stone surface (Farm yard) found in pit 1	0.55
1004	Same as 1003, found in pit 2	0.55

- 6.1 A very brief study of cartographic evidence shows that the area concerning this project was almost certainly part of a farm. It seems probable that the compacted stone surface encountered in both of the test pits was constructed sometime in the 19th century or perhaps earlier, when the farm was still functioning, and then later left *in situ* when the ground was landscaped, perhaps in the later 19th century (Plate 2), around the time of the construction of the railway line which passes close to the site and to the south west.

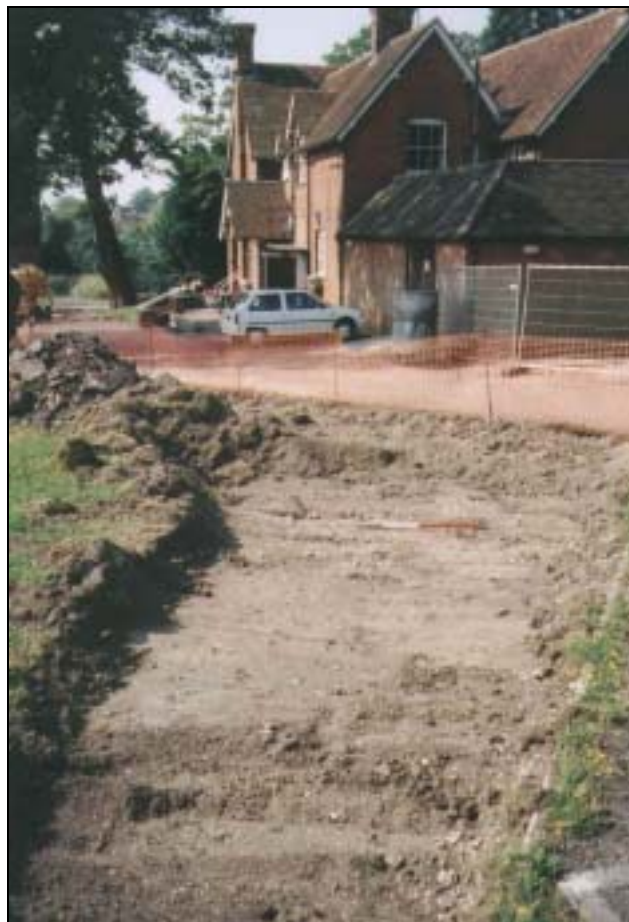
Plate 6: View looking south across area of medieval occupation material

With the exception of the immediate area of the access road off Court Close the landscaping involved only disturbance to the upper 200mm of the local terrain. This included tarmac areas of rubble, top-soil and vegetation. The only area that was of interest lay towards the northern end of the site. Here a crescent shaped area no more than 8 m long by 4 m wide at most had been stripped of its top-soil (see reverse of sheet for August 7th) (Plate 6). This revealed a fine, chalk flecked loam containing small sherds of pottery, tile, glass, bone and slag. The pottery amounted to 16 sherds (95 grammes) and comprised mostly grey coarse wares of post-Conquest date.
