**ARCHAEOLOGICAL WATCHING BRIEF REPORT**

**ALL SAINTS' CHURCH, HILLESDEN,**

**BUCKINGHAMSHIRE**

**APRIL 2016**

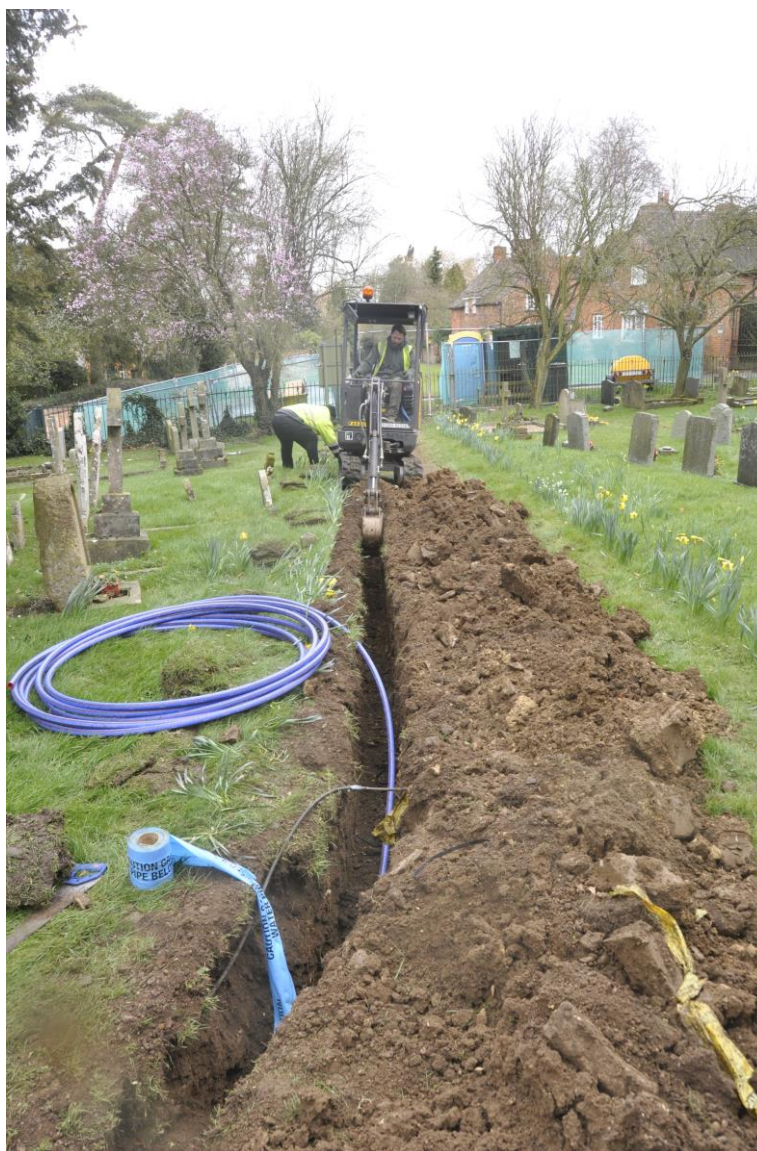
*Plate 1. Service trench under excavation. View to north.*

The archaeological works included inspection of the service trench to the north of the church (Fig. 2), and monitoring of the machine excavation (Plate. 1) of the final 5m. The inspection of the Trench Arch System trench to the south of the church and monitoring of the machine excavation of the final 2m was carried out. The recording of three service pits - two within the church tower, against the north and south walls, one against the external north tower wall was also conducted.

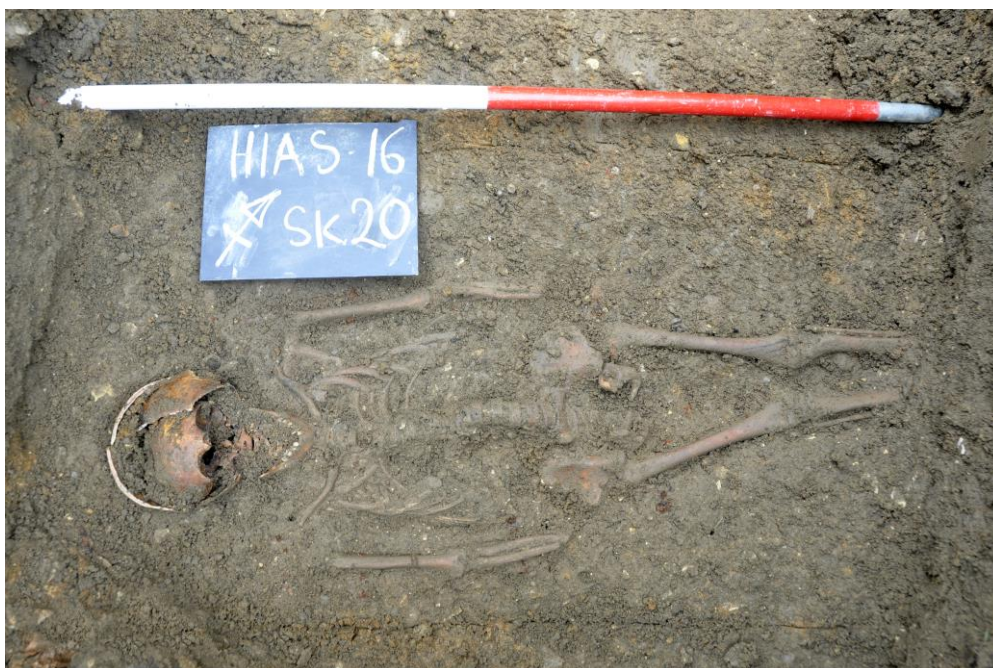
Skeleton No 20 (Fig. 3, Plate. 2) was located c. 5.6m south of the church tower at a depth of 0.59m (105.7m AOD) below the current ground surface.

The skeletal remains comprised upper legs, torso and skull. The lower legs and feet extended beyond the limit of the excavation. Some of the skeletal remains, particularly the hands, had eroded away.

From a photograph the remains were estimated to be between 9 and 10 years of age (pers comm Sharon Clough - Osteoarchaeologist). No pathology was noted. Four nails were recorded, two to the north and two to the south of the remains, providing evidence of a coffin.

*Plate 2. Skeletal remains No 20.*

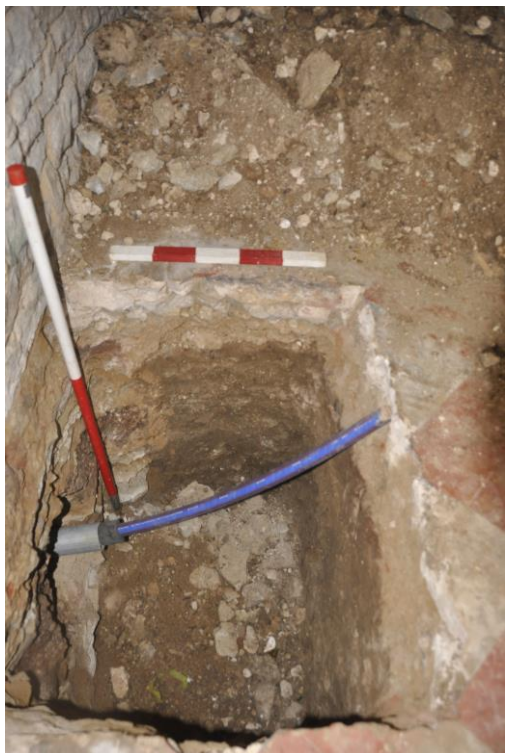
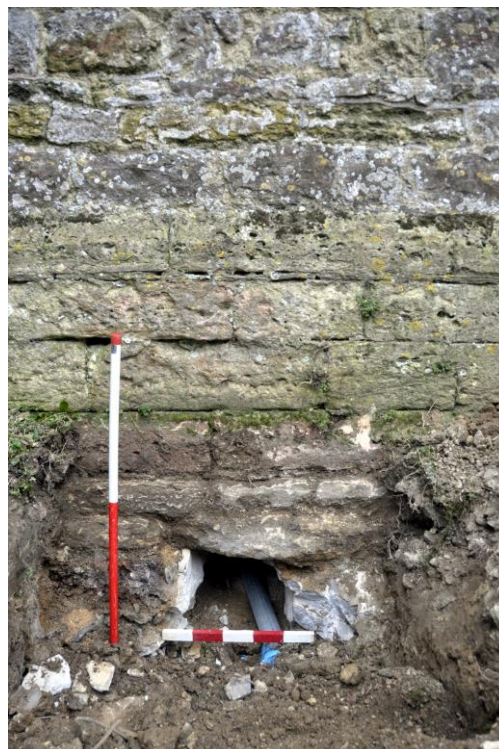
Two service pits were excavated against the north wall of the church tower (Fig. 2), one internally, one externally. An access hole was also excavated through the foundations (Fig. 3, Plates. 3 and 4).

*Plates 3 and 4. Service pits against internal (left) and external (right) north wall (15) of church tower.*

A deposit (13) was observed within both of the service pits excavated within the church tower (Plate. 3, Fig. 3), and comprised moderately compact, mid brown clay silt with 5% small, fragmented human bone inclusions, 0.66m thick. This deposit almost certainly represents a graveyard soil formed prior to the construction of the church tower in the early 15<sup>th</sup> century. This deposit was cut by the construction of the north tower wall (14). Both the wall (14) and graveyard soil (13) were overlain by a deposit (12) of loose limestone rubble, 0.14m thick. This deposit is probably associated with the tower floor, as suggested by its looseness and general character, although the possibility it is associated with the construction of the tower cannot be discounted. Deposit 13 was overlain by a layer of concrete rubble (11), a levelling layer for the current tower floor, which is formed from modern, orange and grey earthenware tiles (10) laid in a checkerboard pattern.

The north tower wall (Plate. 4, Fig. 3) was recorded to a depth of 0.64m from the current ground surface (the base of the foundations were not revealed). It was constructed from undressed limestone (0.8m x 0.4m) in random linear courses, bonded (where visible) by a pale yellow sandy mortar.

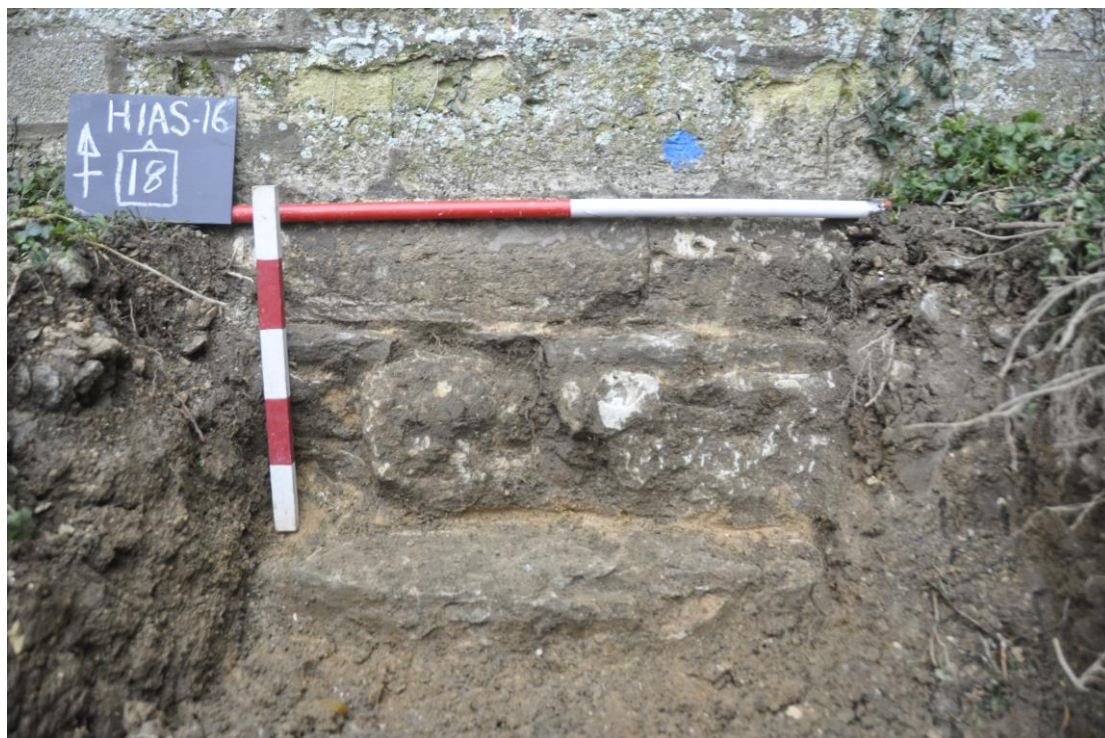
The south tower foundations (Plate. 5, Fig. 3) was recorded to a depth of 0.6m from the current ground surface (the base of the foundations were not revealed). The base of the foundations was formed from a large undressed limestone (as seen), measuring 0.9m x 0.2m x 0.01m, forming a stepped foundation base. This was overlain by a generally linear course of undressed limestone, 0.3m wide, 0.3m high, bonded by a pale yellow sandy mortar. The foundations were overlain by a (above ground) chamfer course.

**Plate 5.** Southern, external foundations (18) of tower. Note stepped foundation and chamfer course. View to north.
