## **EXCAVATION AND WATCHING BRIEF: ST JOHN THE BAPTIST CHURCH GRANBOROUGH BUCKINGHAMSHIRE**

NGR: SP 7678 2500

November 2010

ASC: 1340/GSJ/3

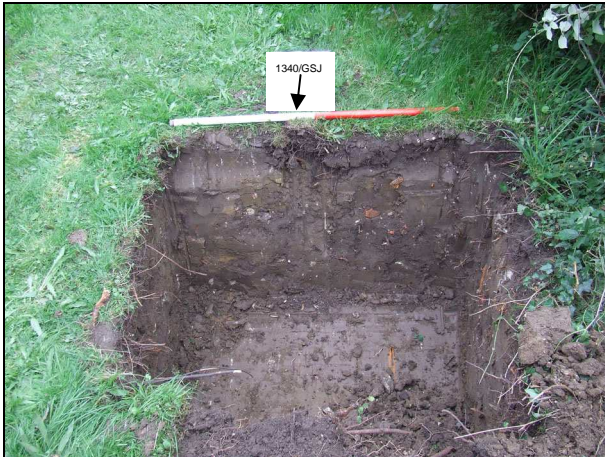
The soakaway and the initial 300mm ground reduction uncovered no significant archaeological features, deposits, finds or human burials from the excavation areas. Towards the southwest corner of the excavation area heavy root disturbance and tree stumps were present.

**Plate 1:** North facing section of soakaway, looking S (*scale 1m*)

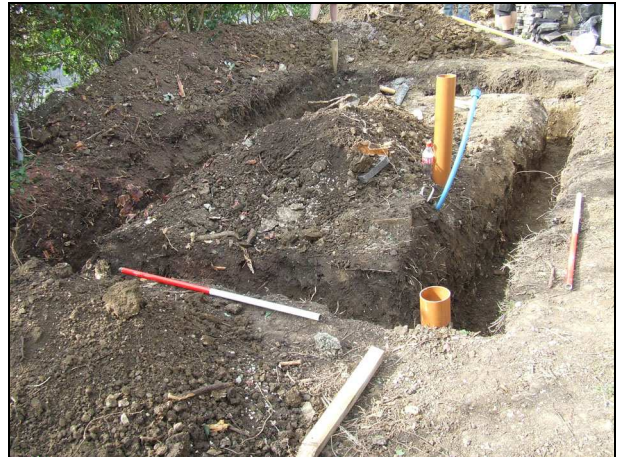
An area of c.12.70 sq m encompassing the new toilet and a 1×1m soakaway was mechanically excavated with a 1m toothless bucket. The new toilet area was initially excavated to a level of c.300mm, after which a watching brief was carried out on the footing trench within the stripped area (see section 4.2.1). The soakaway was excavated to a depth of c.0.80m max.

**Plate 2:** Excavation area of new build and footing trench, looking NW (*scale 2x1m*)

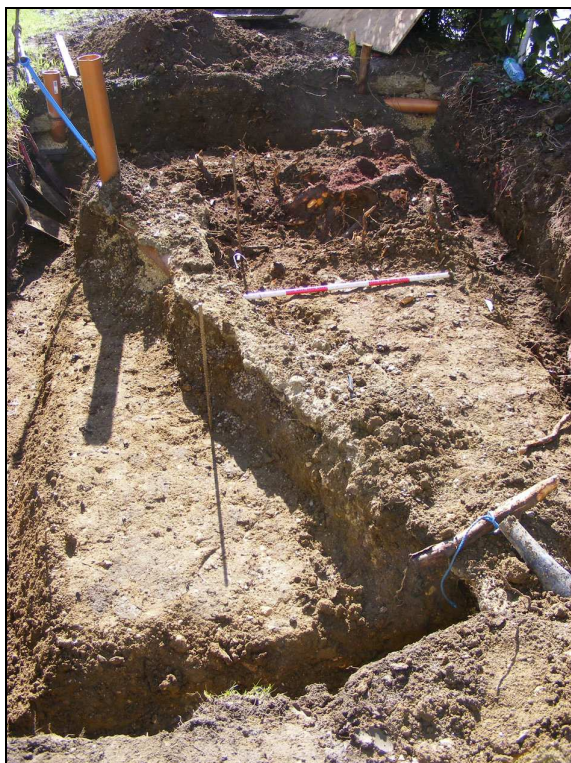
A further 300mm was hand excavated in the new toilet area. The ground reduction uncovered remains of a limestone surface (see below for further details), c.0.50m BGL (below ground level). Two fragments of animal bone, one fragment of human bone and small tile fragments were also found within the made-ground.

**Plate 3:** New toilet area excavated a further 300mm exposing limestone surface towards the east, looking S (*scale 1m*)

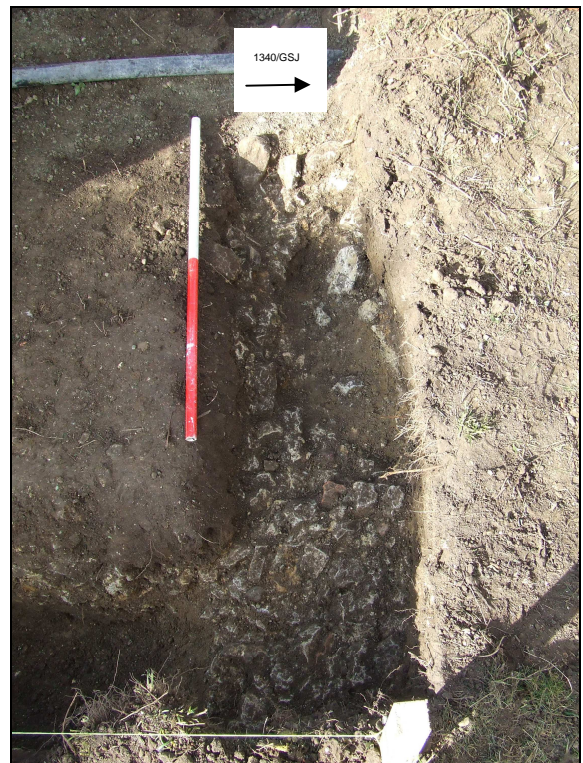
At the northern end of the trench the maximum stone size of the surface measured *c.*170 × 110 × 80mm. At the southern end the surface had a number of stones that were flatter, measuring a maximum size of *c.*180 × 190 × 20mm. The surface at the northern end of the trench included traces of light yellowy orange loose sand underlying the stone.

**Plate 4:** Limestone surface at northern end of footing trench, looking W (*scale 1m*)

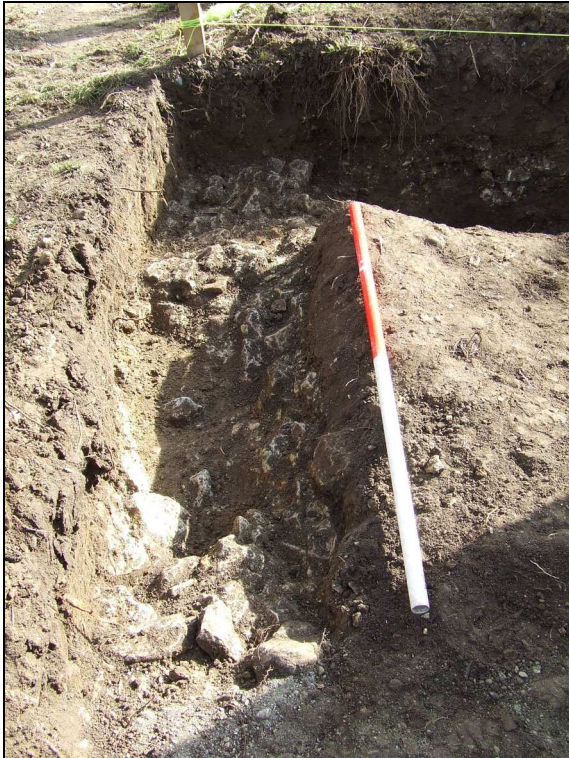
**Plate 5:** Limestone surface at northern end of footing trench, looking E (scale 1m)

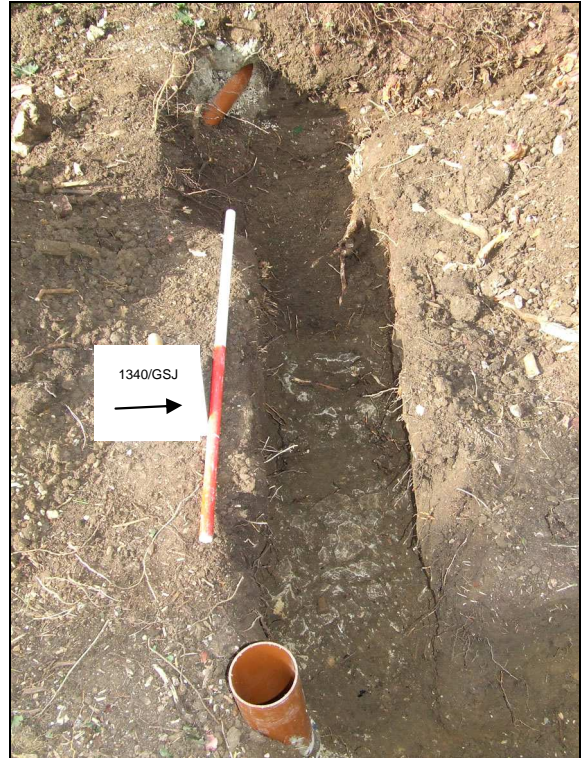
**Plate 6:** Limestone surface at southern end of footing trench, looking W (scale 1m)

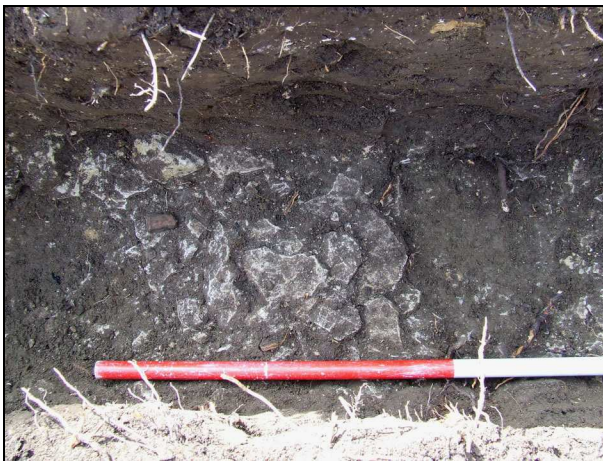
**Plate 7:** Limestone surface detail at southern end of footing trench, looking S (Scale 500mm)

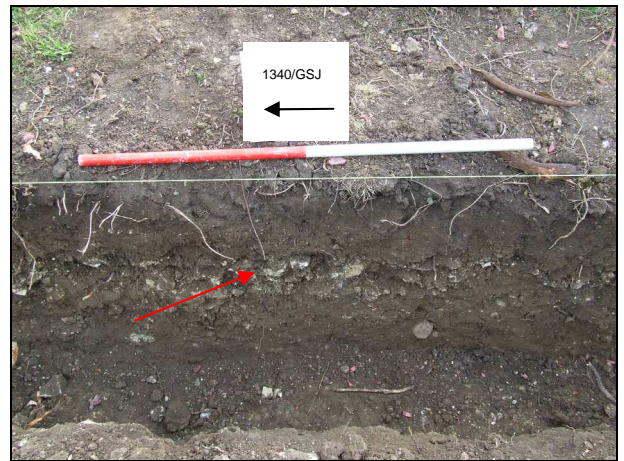
A compact sub-angular limestone surface, with no bonding, was uncovered at the northern and southern ends of the footing trench during excavation. The surface also extended into the eastern end of the footing trench, which was not noticed during excavation due to the surface being less compact in this area and less noticeable. Therefore, the surface at the eastern end of the footing trench was only identified in section and measured *c.*3.60m in width.

**Plate 8:** West facing section of eastern end of footing trench highlighting limestone surface in section, looking E (scale 1m)

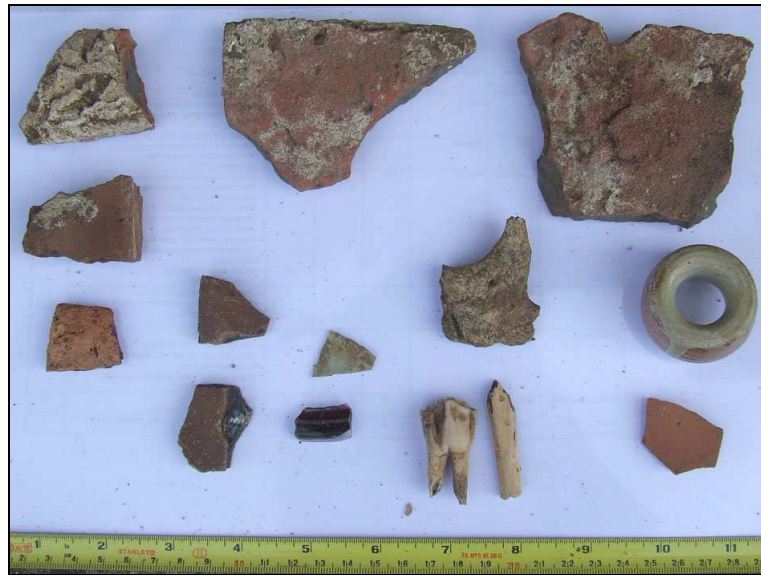
During the excavation of the surface area a number of finds deriving from immediately above and within the surface comprised one disarticulated human bone, animal bone and tooth, glass, tile with traces of a light brown/orange mortar, post-medieval pottery and pottery with the date undetermined.

**Plate 9:** Finds deriving from limestone surface area (*scale 270mm*)

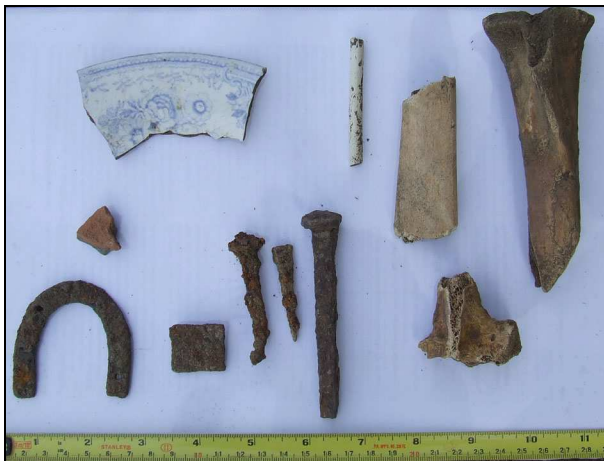
Further finds from the footing trench was a fragment of white and blue 'willow pattern' pottery dating to *c.*19<sup>th</sup> century, animal bone, clay pipe stem, iron nails, iron square fitting, iron shoe fitting, and pottery (date undetermined).

**Plate 10:** Finds deriving from footing trench  
(*scale 280mm*)

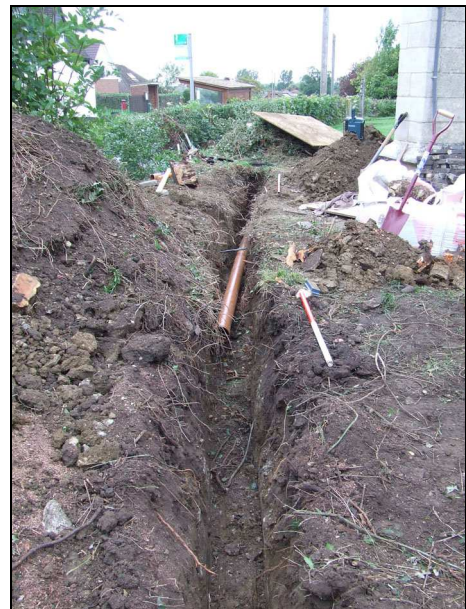
Service trench 1 was orientated NW-SE and measured *c.*8.50m in length, to a depth of *c.*0.50-0.90m BGL. Towards the NW end of the trench, evidence of 20<sup>th</sup> century pottery, plastic, and metal was uncovered indicating modern disturbance near to a recent man-hole.

**Plate 11:** General view of service trench 1,  
looking NW (*scale 2x1m*)

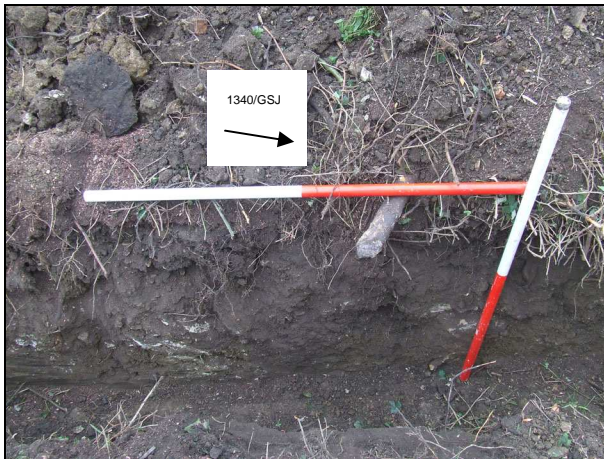
**Plate 12:** NE facing section of service trench 1, looking NW (scale 2×1m)

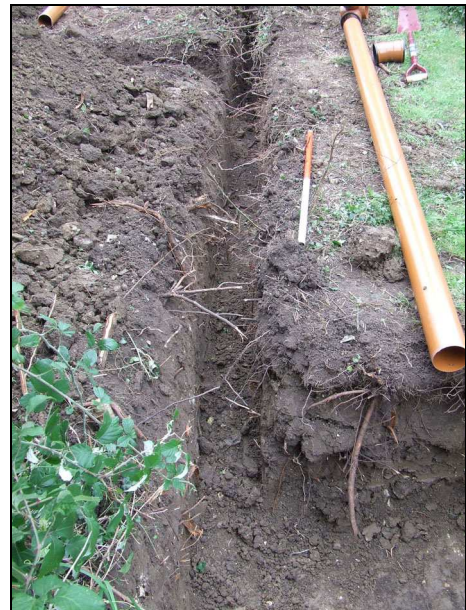
Service trench 2 was oriented N-S and measured *c.*4m in length, to a depth of *c.*0.57-0.68m BGL. Two elongated pieces of iron were uncovered, deemed to be of little archaeological significance.

Service trench 3 was orientated NW-SE and measured *c.*2.90m in length, to a depth of *c.*0.50-0.60m BGL. The made-ground contained a glass bottle, a clay pipe stem, and an iron rivet for a fence, of little archaeological significance.

**Plate 13:** General view of soakaway with service trench 2 and 3, looking N (scale 1m)

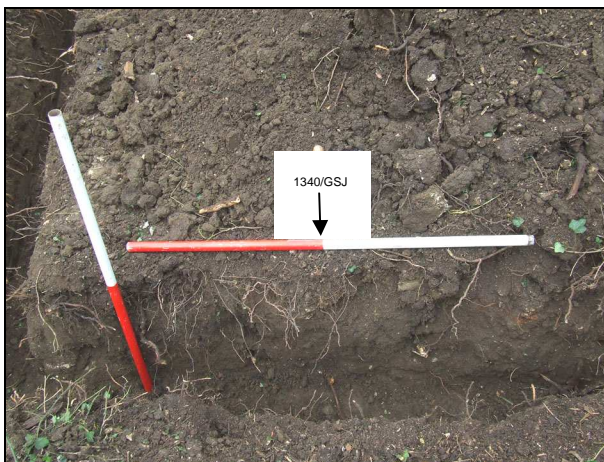
**Plate 14:** N facing section of service trench 3, looking S (scale 2×1m)

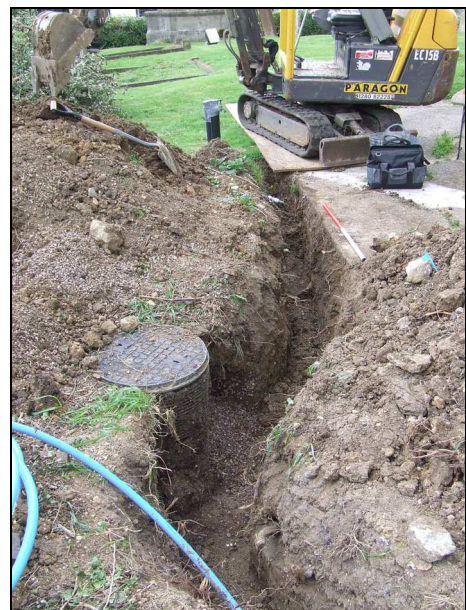
Service trench 4 was oriented SW-NE and measured *c.*4m in length, to a depth of *c.*0.70m max BGL. The made-ground contained recent disturbance of buried plastic near to the man-hole.

**Plate 15:** General view of service trench 4, looking NE (scale 1m)

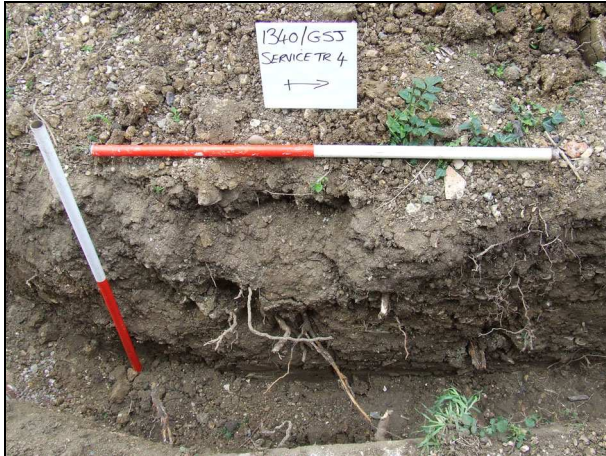
**Plate 16:** E facing section of service trench 4,  
looking W (scale 2×1m)

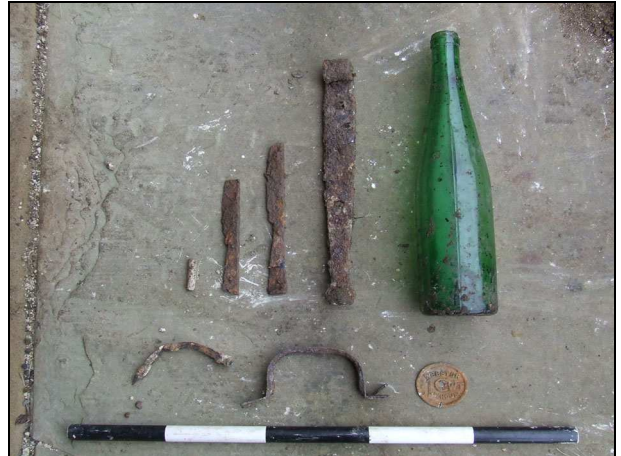
No significant archaeological features, deposits, finds or human burials were uncovered from the service trenches.

**Plate 17:** Finds deriving from service trenches  
(scale 250mm)
