ARCHAEOLOGICAL WATCHING BRIEF

AT FOSCOTT OLD CHURCH,

BUCKINGHAMSHIRE

JANUARY 2010

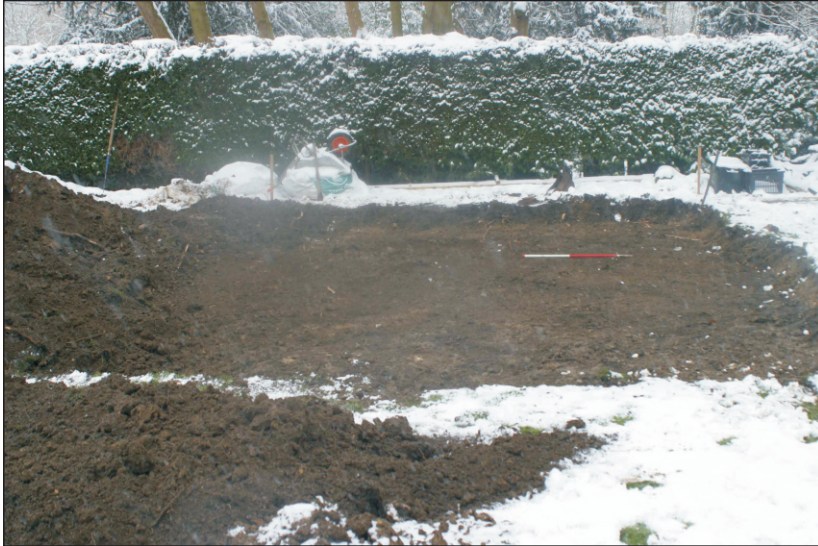
Figure 2. Barn area, looking west

The barn was excavated to a deposit of brown clay silt (3), which probably represents the interface of the original topsoil and the subsoil (Fig 2); this surface was at 102.1m OD. No finds were recovered from this deposit. This interface deposit, which represents a reduced, or stripped, level probably associated with earlier groundworks, was sealed by 200mm of dumped yellow clay (2) (Fig. 3) containing modern ceramic building material and a penny dating from 1980. The penny was not retained. The access area to the south of the barn was excavated to a depth of 200mm and so did not go through the clay dump (2) (Fig. 4), which can be seen to the bottom of the photograph. The area was sealed by topsoil (1), which measured 100mm thick.
