**An Archaeological Standing Building Survey
Market Hall
Amersham
Buckinghamshire**

On Behalf of Amersham Town Council

ABRS Project No 2021-MHAB

**Planning Application No
PL/19/2918/HB**

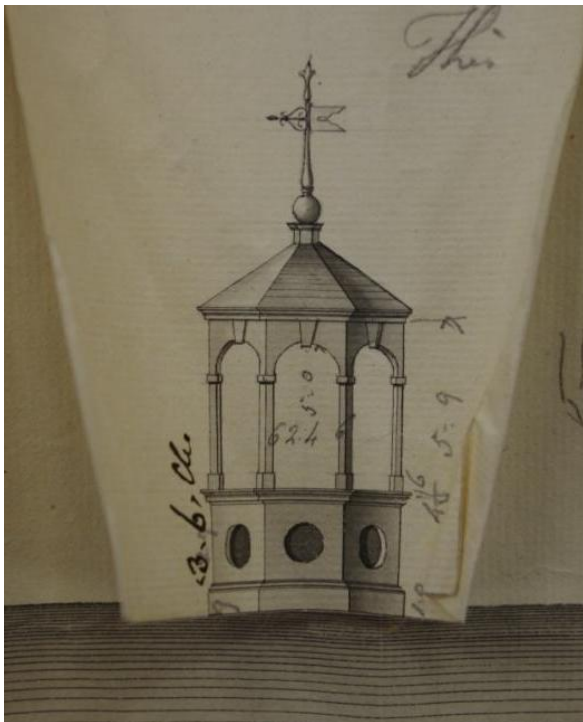
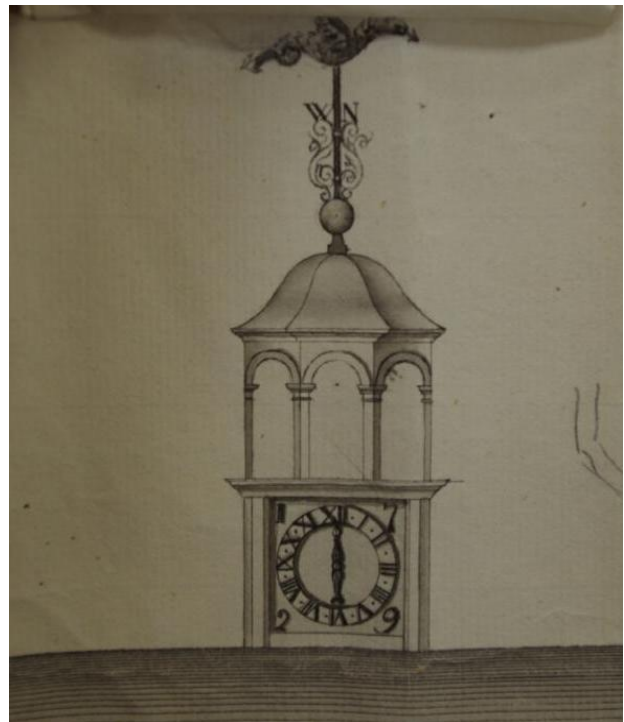
Figure 3

It was Sir William, in 1682 who endowed the town with its Market Hall. It was intended that the upper floor be used for meetings, such as those for traders' guilds and the ground floor as a market. The Centre for Buckinghamshire Studies (CBS) holds a number of apparently original architectural plans relating to the Market Hall, although two of the papers bear the watermark "GR", for George I who only succeeded the throne in 1714, so the exact date of the drawings is open to debate. The elevation drawing (CBS Ref D-BASM/2/57 (*Figure 2*)) gives an extremely clear representation of the building indicating that it was built largely as it was designed, with only subtle changes to the window heads and arches, the two being more plainly finished than apparently intended. The eaves corbelling does not appear on the drawing either. Interestingly, the bell turret and clock, as it stands now is shown as an overlay, below which is apparently the proposed, but not built design (CBS Ref D-BASM/2/57 (*Figure 3*)). There are clear differences between the two proposals; the proposed tower appears to be square in plan with an octagonal arcade and ornate weather vane. Interestingly, this proposed tower bears the date 1729 on the clock face, which along with water marked paper dating to post 1714 raising the intriguing possibility that the clock tower as a whole is a later, early 18th century addition to the 1682 Market Hall, potentially celebrating the fiftieth anniversary of the Hall.

Clock Tower – Actual.

Clock Tower – Proposed.

Architectural drawings and measurements for Amersham market hall and clock tower (c. 1682 - 1714).

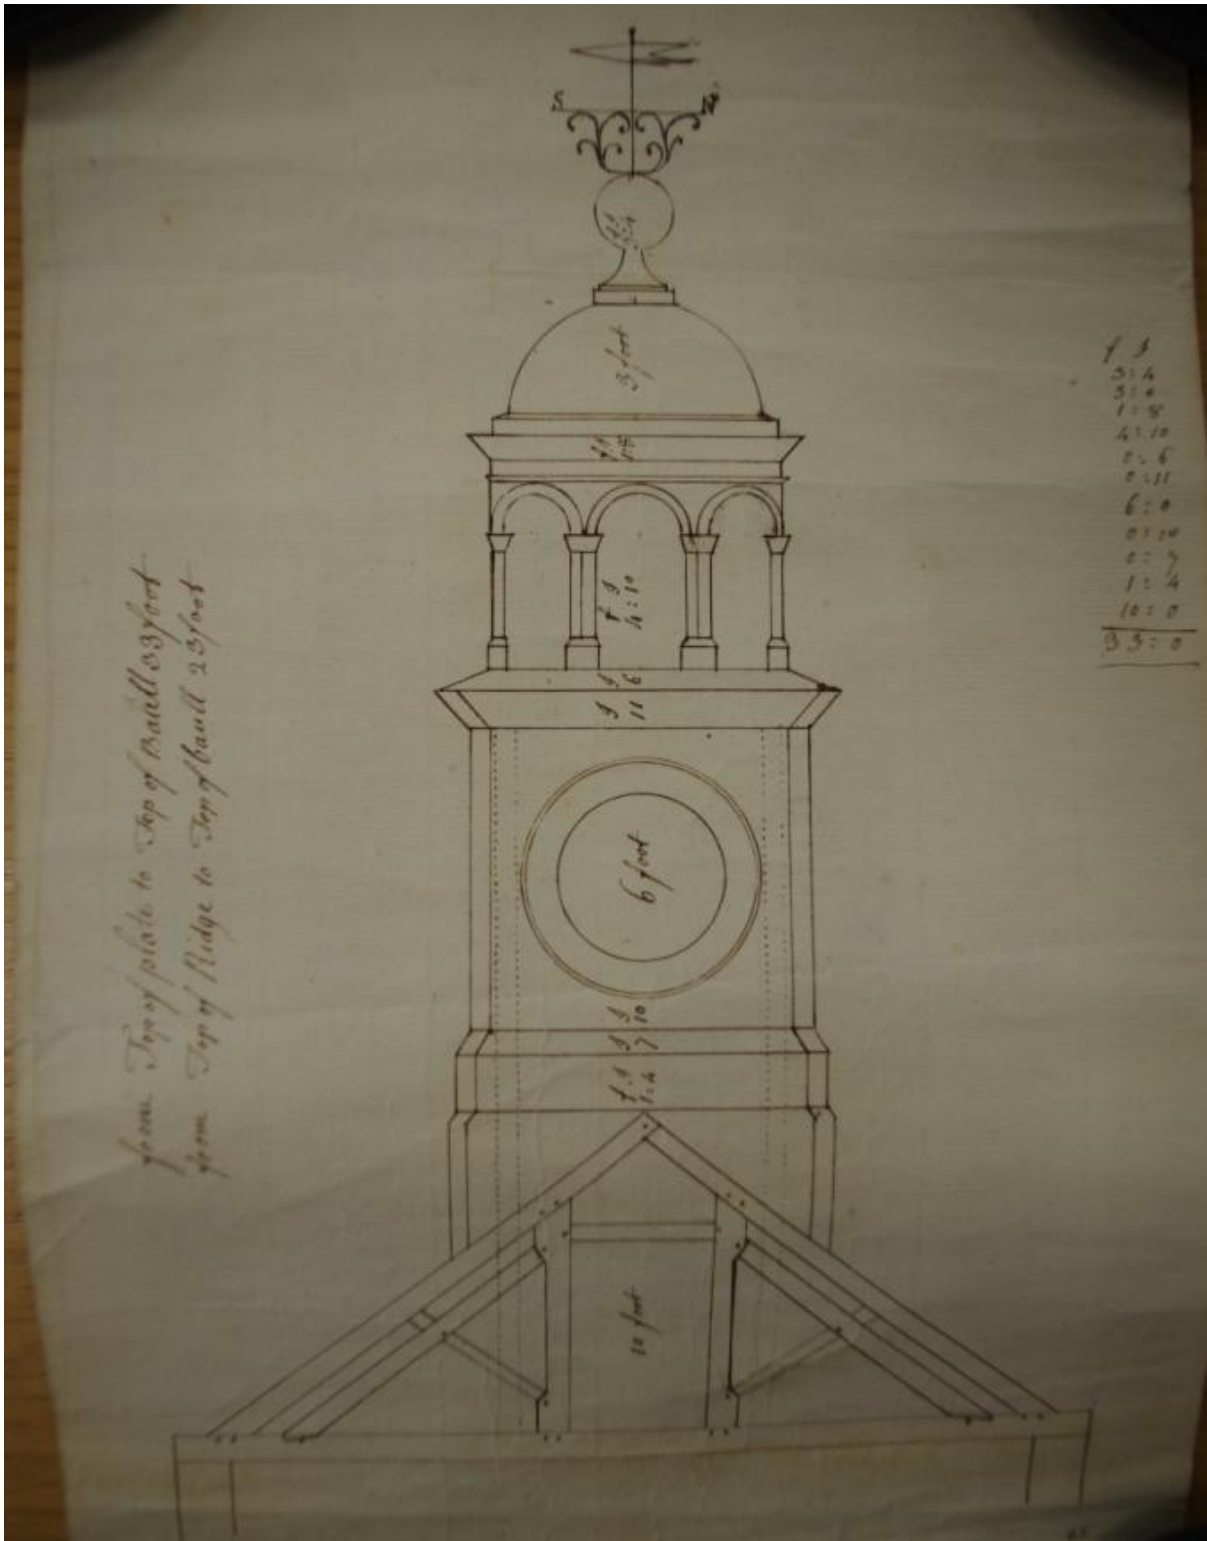
Figure 4
Architectural drawings and measurements for Amersham market hall and clock tower (c. 1682 - 1714).

Other drawings within the same group include two further options including what appears to be a truly huge tower, towering 30 feet above the roofline (CBS Ref D-BASM/2/57 (*Figures 4 & 5*)). The drawings also include a proposed offset location for the clock tower (CBS Ref D-BASM/2/57 (*Figure 6*)).

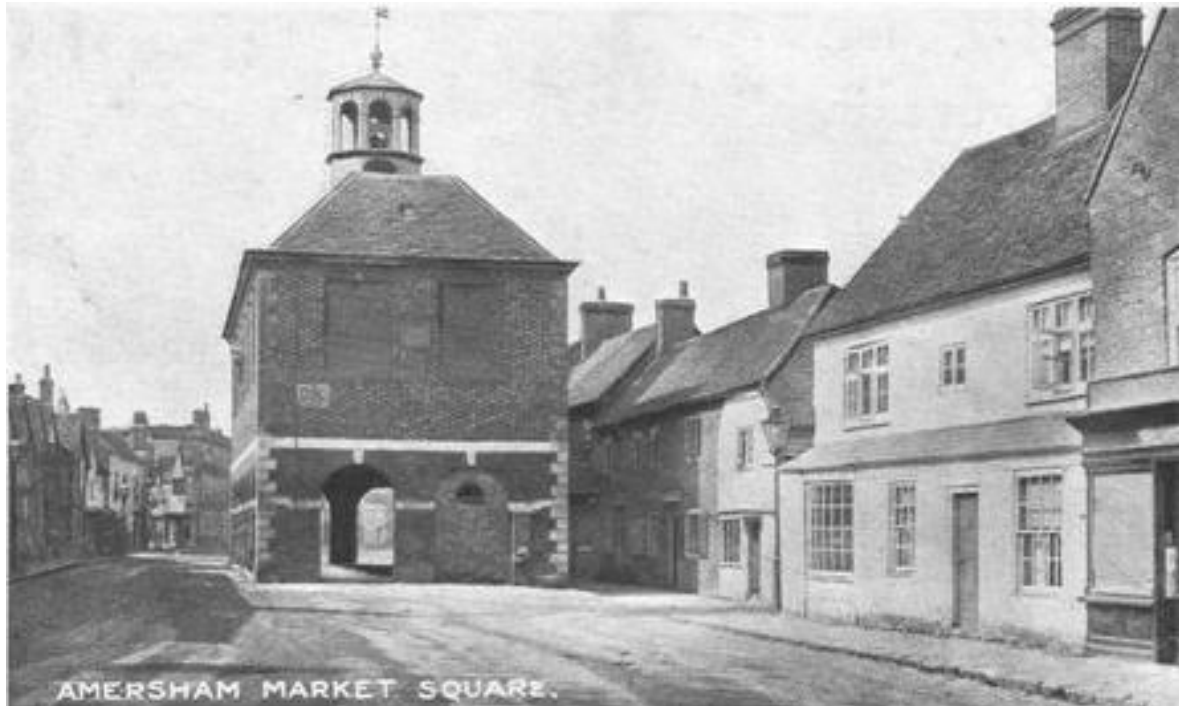
Figure 8
Late 19th Century (?) Photograph.

CBS holds a number of photographs of the Market Hall, most are un-dated, but are likely to be late 19th or early 20th century in date. A view of the east facing elevation (CBS Ref PHX/1996 (*Figure 8*)) appears to show either a blank face or a black face to the clock. An

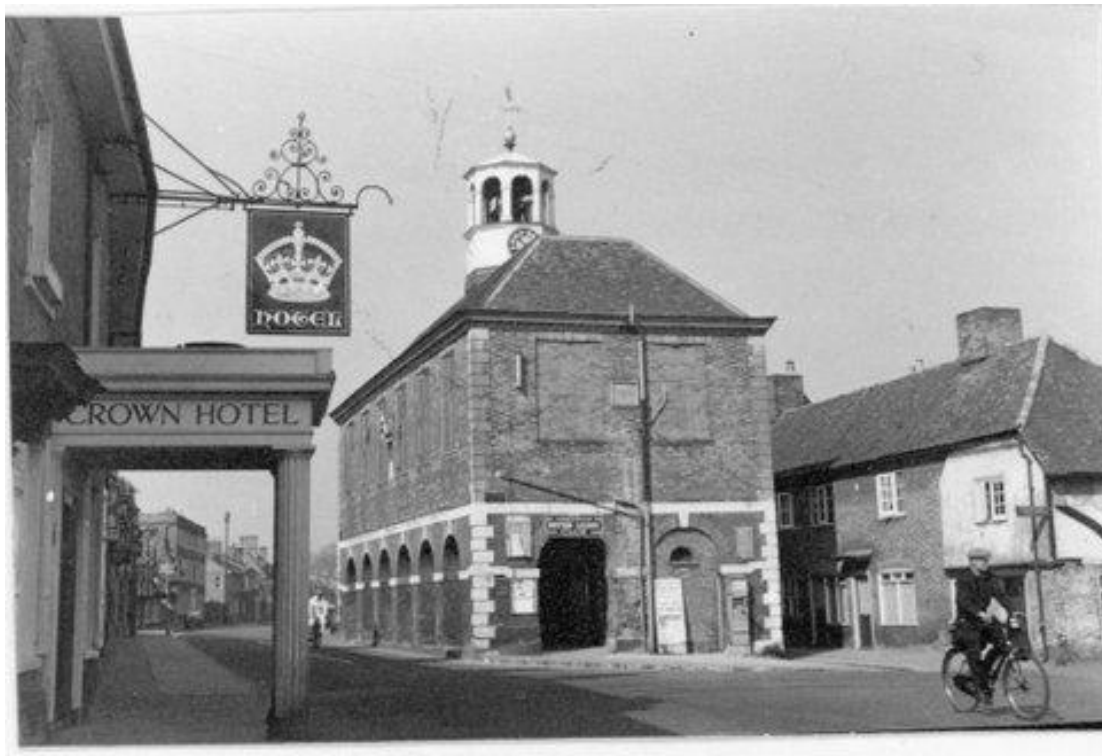
Figure 9
Early 20th Century Photograph.

apparently later photograph (CBS Ref PHX/1645 (*Figure 9*)) is clearer and confirms the clock as having fewer faces, with no clear evidence of a face on the south facing elevation.

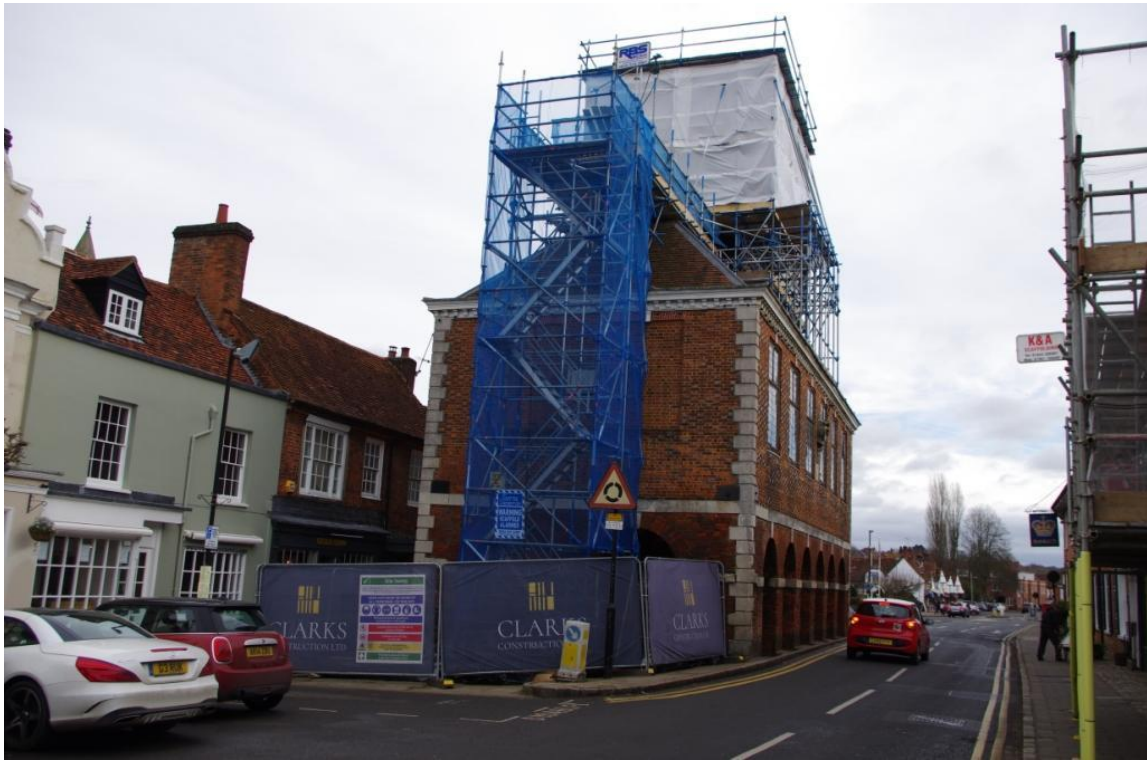
Figure 11
Market Hall, General View (Looking East).

Amersham Market Hall is a two storey, brick-built former market hall; the ground floor is arcaded with brick arched openings. The roof is hipped with a central secret valley clad in plain tiles (*Figure 11*).

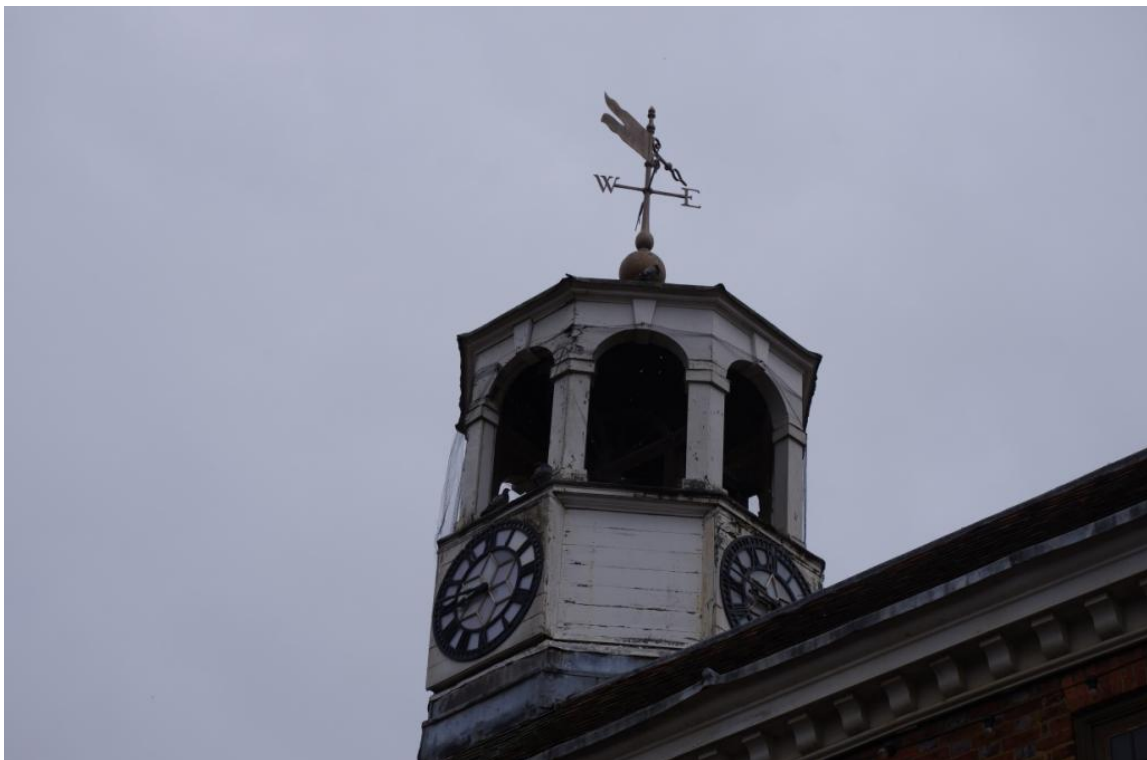
Figure 12
Clock Tower, General View (Looking North West).

The clock tower and bell turret atop the Market Hall is located within the centre of the building within a valley between the two roofs and consists of an octagonal timber framed structure supporting a wooden cupola consisting of drum with clock faces facing north, east,

south and west under a round headed open arcade and flattened conical roof, topped with a gilded ball and weather vane (*Figure 12*).

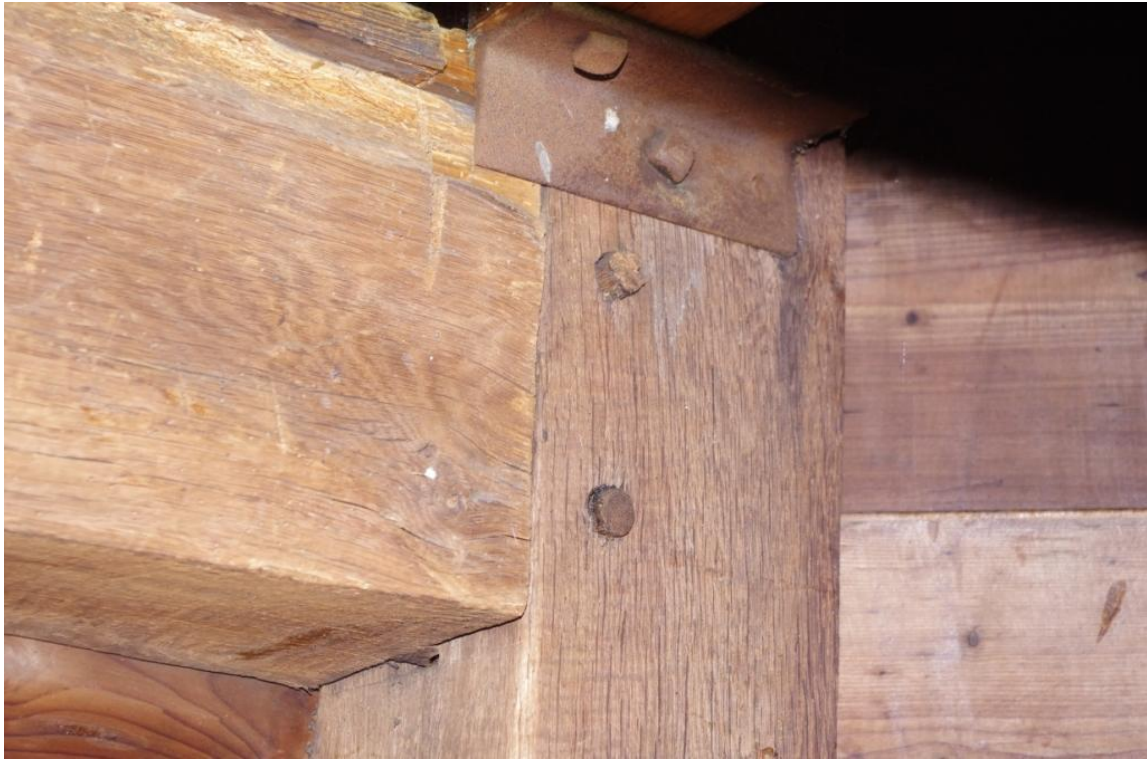
Figure 13
Pegged Frame.

The eight bay posts rise from wall plate level. The main frame members are pegged (*Figure 13*) and there are some examples of incised assembly marks (*Figure 14*), all in Roman numerals, all apparently contemporary, indicating the structure is original and un-altered. There are some diagonal braces, the use of deal for these braces suggests that they are later insertions, perhaps added to strengthen the structure.

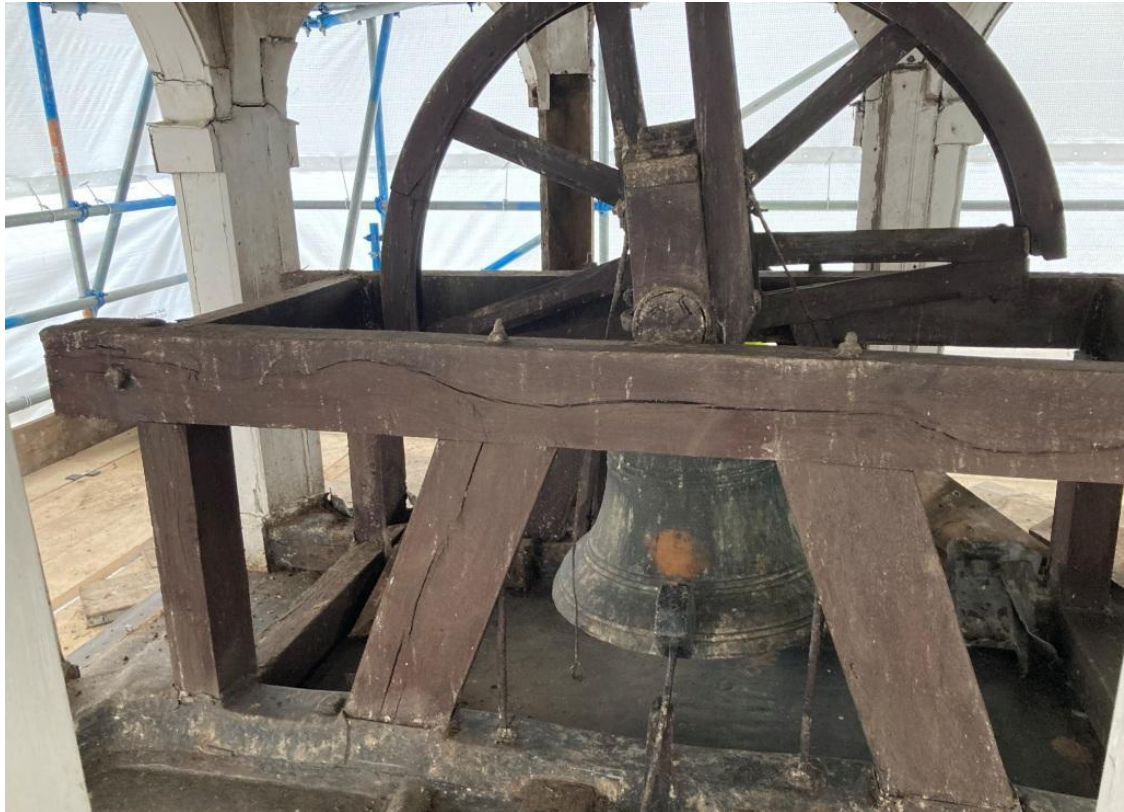
Figure 15
Bell Frame (Looking North).

Within the open arcade is an oak bell frame carrying a bell. The bell is said to be inscribed “C. H. made me 1682”. C.H could conceivably be Christopher Hodson, the London based bell-founder who worked extensively between 1669 and 1696. The bell frame is a bolted frame and unlikely to be original. The bell frame (*Figure 15*), as part of the work was removed. Although bolts have clearly been used the frame is also jointed with dovetail joints (*Figure 16*), so it is possible, that although not original the bell frame may be of some significant age.

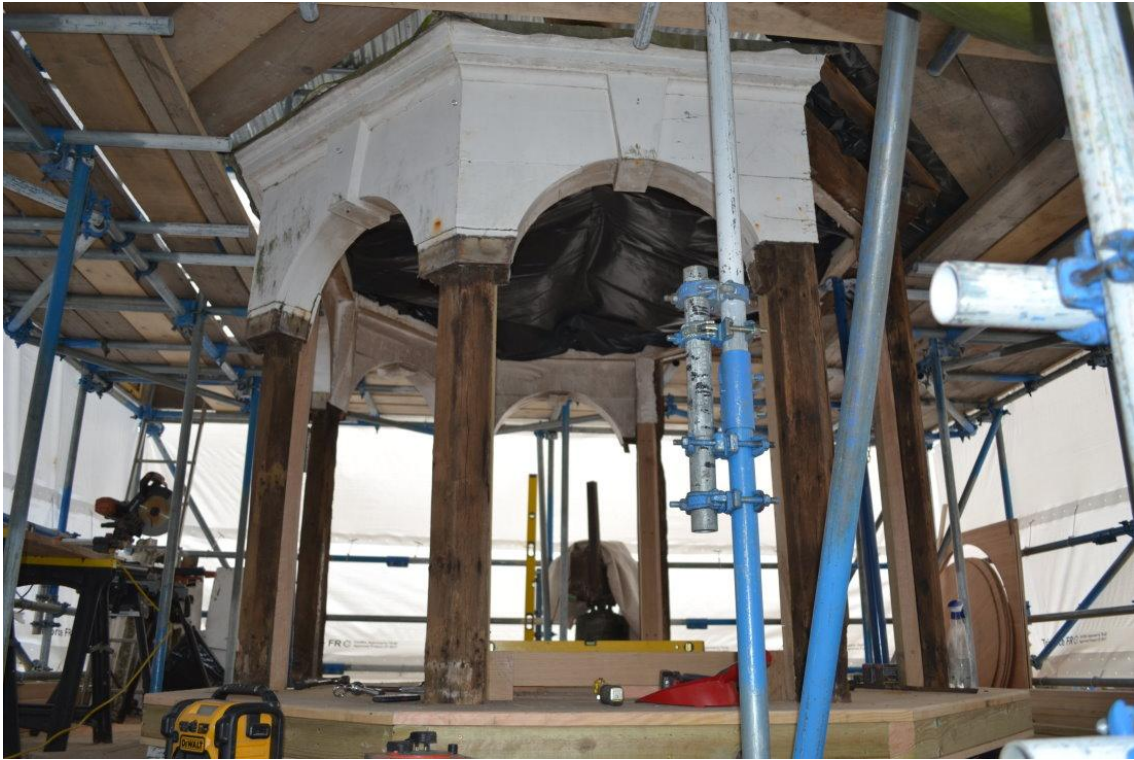
Figure 17
Clock Tower, Exposed Posts (Looking East – South East).

The exposed structure consists of eight posts (*Figure 17*), all in oak. The wall plate is lapped at each angle and pegged (*Figure 18*). The bay posts have been severely truncated, leaving a much reduced cross section at the bases (*Figure 19*). The tops of the posts are jowled, which appears to be original to support the wall plate, although it is clear that fillets have been added to at least one of the posts, possibly as a later repair.

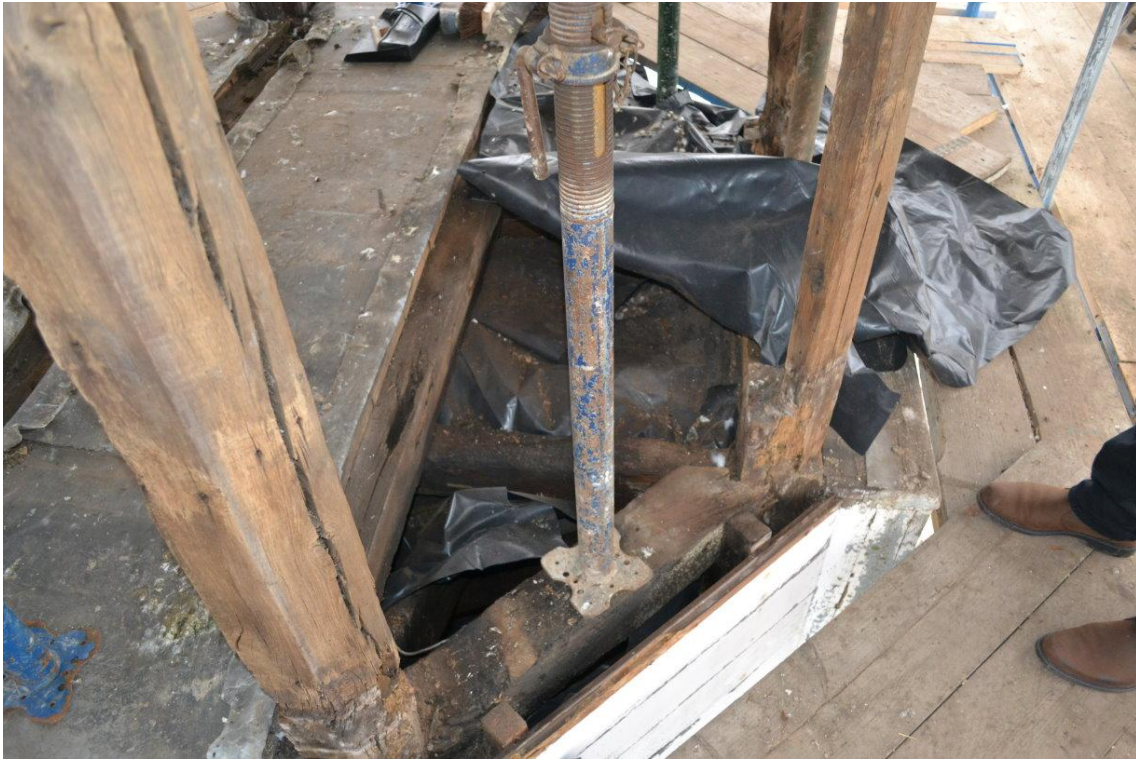
Figure 19
Base of Posts Showing Truncation (Looking East – South East).

There is both physical and documentary evidence that the clock tower has undergone significant repair and potential re-building works. The drum was clad in modern softwood planking, almost certainly dating to the 20th century. The posts have been truncated, potentially to accommodate this planking leaving a much reduced cross section. There is also evidence that the bell frame may be a 19th or early 20th century replacement.
